STAINLESS STEEL FOR INDOOR SWIMMING POOLS

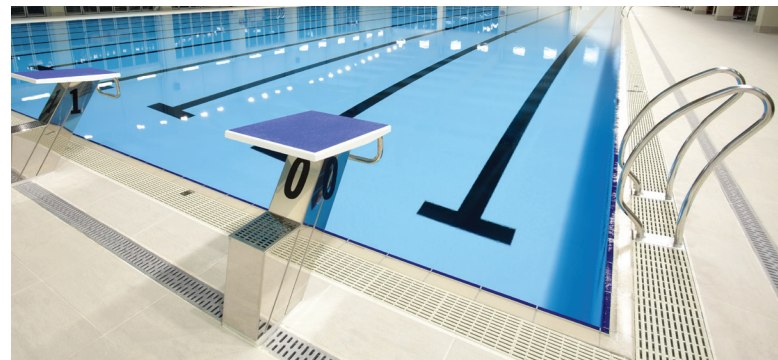
The message about alloy choice has had good penetration although those new to stainless steel for indoor chlorinated pools still suggest 316 bolts to support overhead spotlights, 316 bolts over heavily chlorinated wastewater tanks or 316 cables or struts to hang water slides. There were cases of fabricators substituting 304 hangers for the specified painted and galvanised hangers for pool lighting panels – which sagged when several broke as shown in the picture on the left.

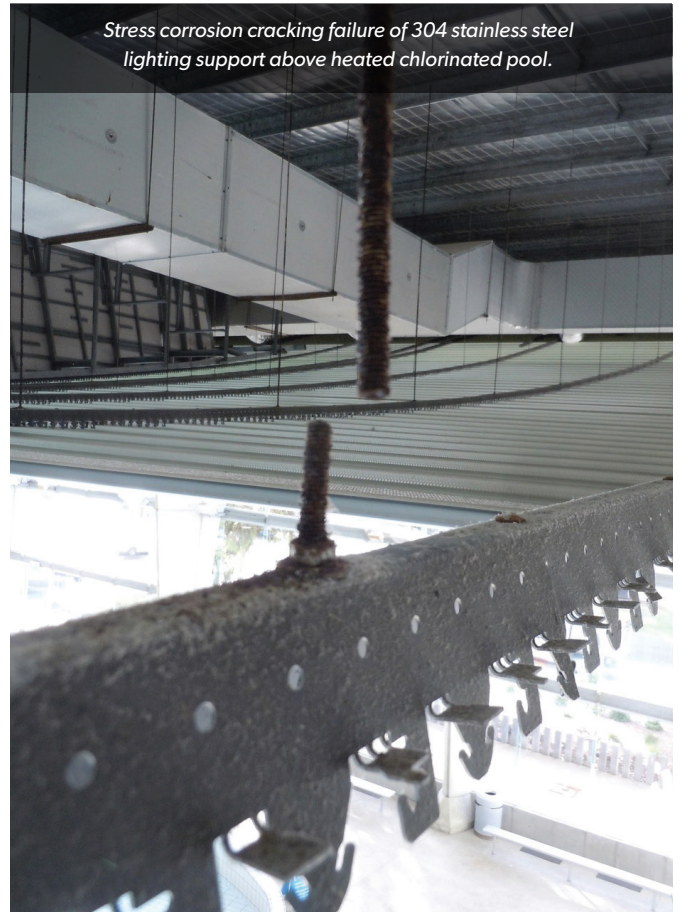
Stress corrosion cracking failure of 304 stainless steel lighting support above heated chlorinated pool.
